D868UV firmware update V1.17 and V2.17

Hardware V1.0 --- Please use the firmware V1.17 for updating the radio. **Hardware V1.1** --- Please use the firmware V2.17 for updating the radio.

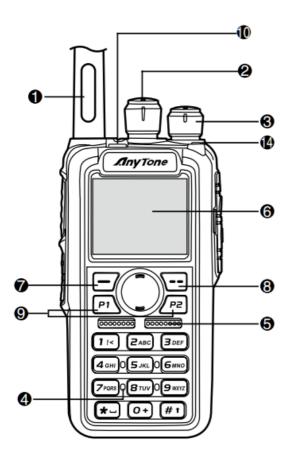
Press 7 (Menu) key to enter the menu, press very key to the Device Info and enter into the menu to check the hardware version.

Hardware V1.0 --- Please use the firmware V1.xx for updating the radio.

Hardware V1.1 --- Please use the firmware V2.xx for updating the radio.
