D868UV firmware update V1.19 and V2.19

Hardware V1.0 --- Please use the firmware V1.19 for updating the radio.
Hardware V1.1 --- Please use the firmware V2.19 for updating the radio.

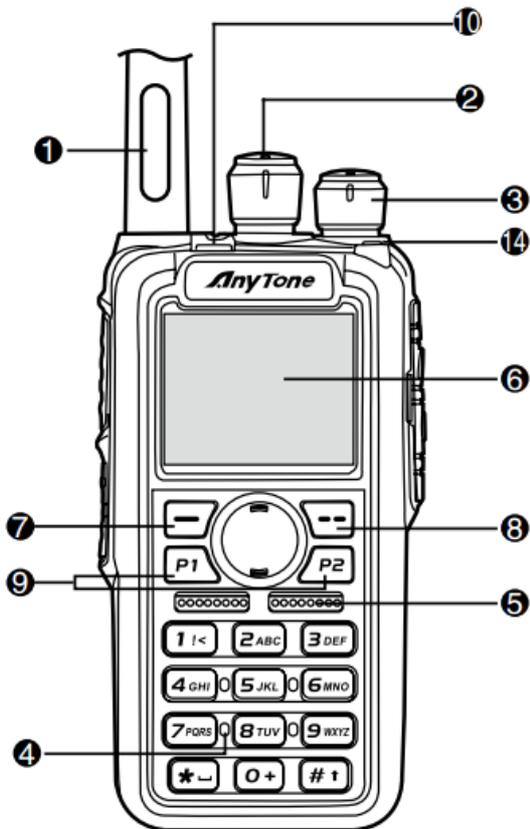
CPS change dated 2017-12-16
CPS ->Optional setting->Others
1. VFO scan start and end frequency, allow set up the VFO scan range
2. Enhanced Sound Quality, allow set up the tone to high pitch or low pitch for transmitting.
3. Call channel is maintained, when radio receive signal at sub band, allow press PTT to

response to the call in 5seconds after the carrier drop.
