## DMR Series

### [CS800 Firmware Upgrade Guidelines \(S1.01.04 Main and R1.00.02 Front Panel\)](#)

#### Preface:

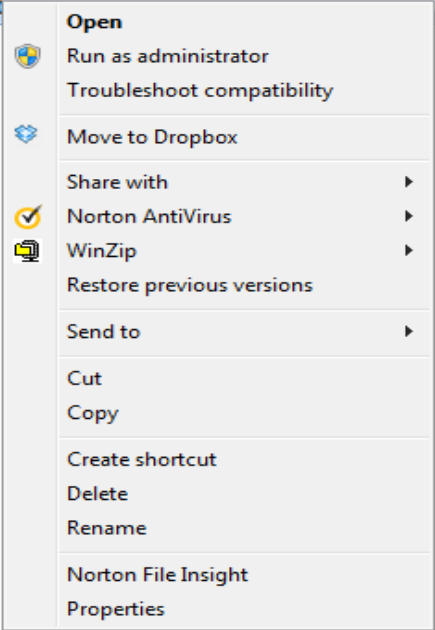
- 4) Click on “Run as administrator.”
- 5) If prompted by the software, allow it to uninstall previous versions of Prolific drivers to insure that the cable will properly connect.

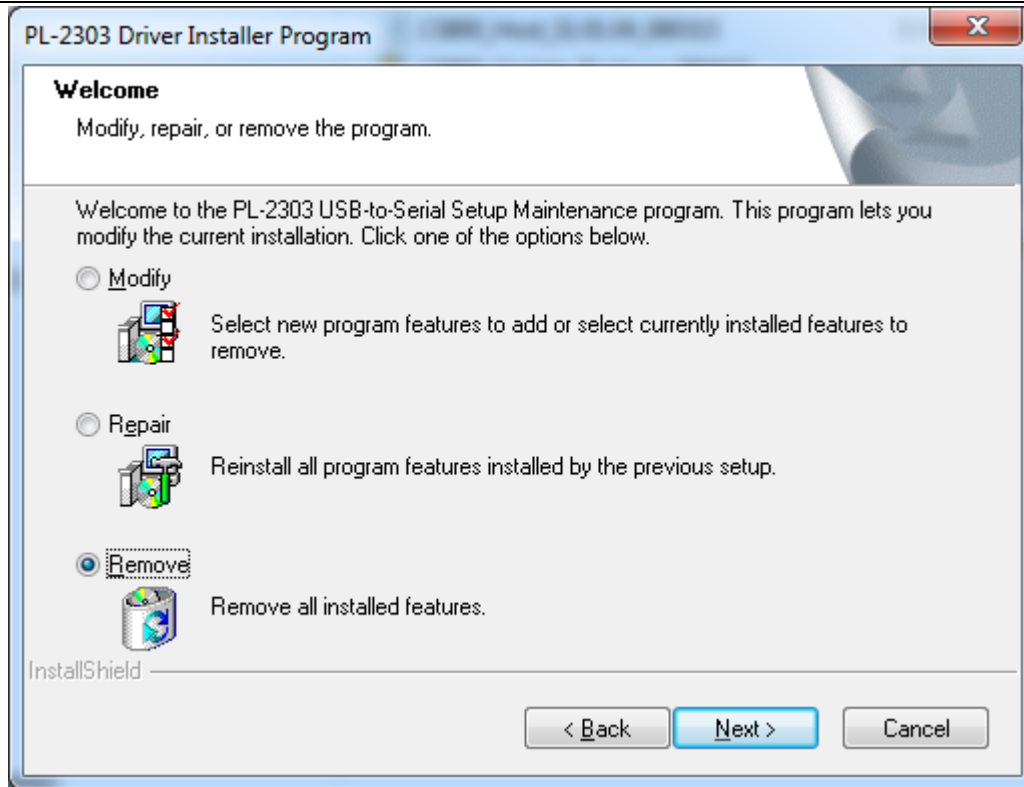
Press Next and if you follow the instructions it should remove the old driver and install a new driver.

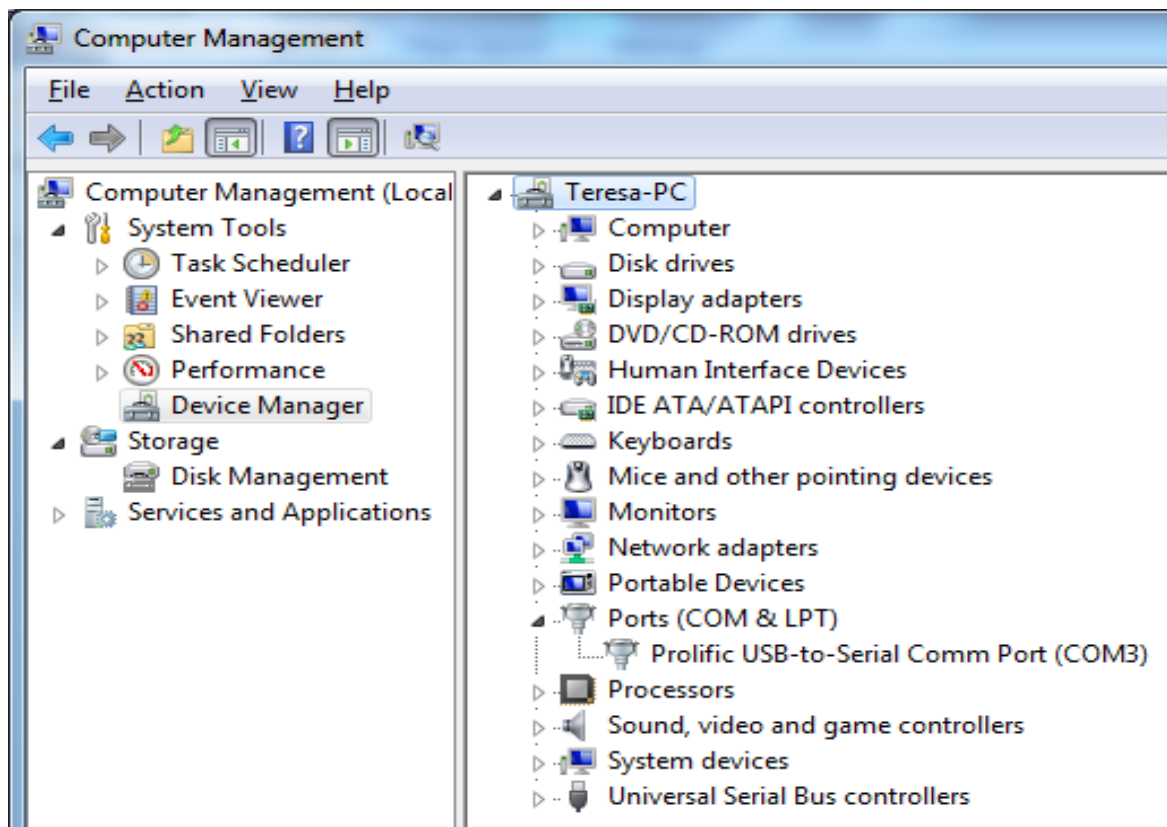
- 10) expand the 'Ports (COM & LPT)' menu, and find 'Prolific-USB-to-Serial Comm Port (COM#)'. Make a note of the COM port # as it will be needed later in the upgrade program.

Note in this computer it says COM3

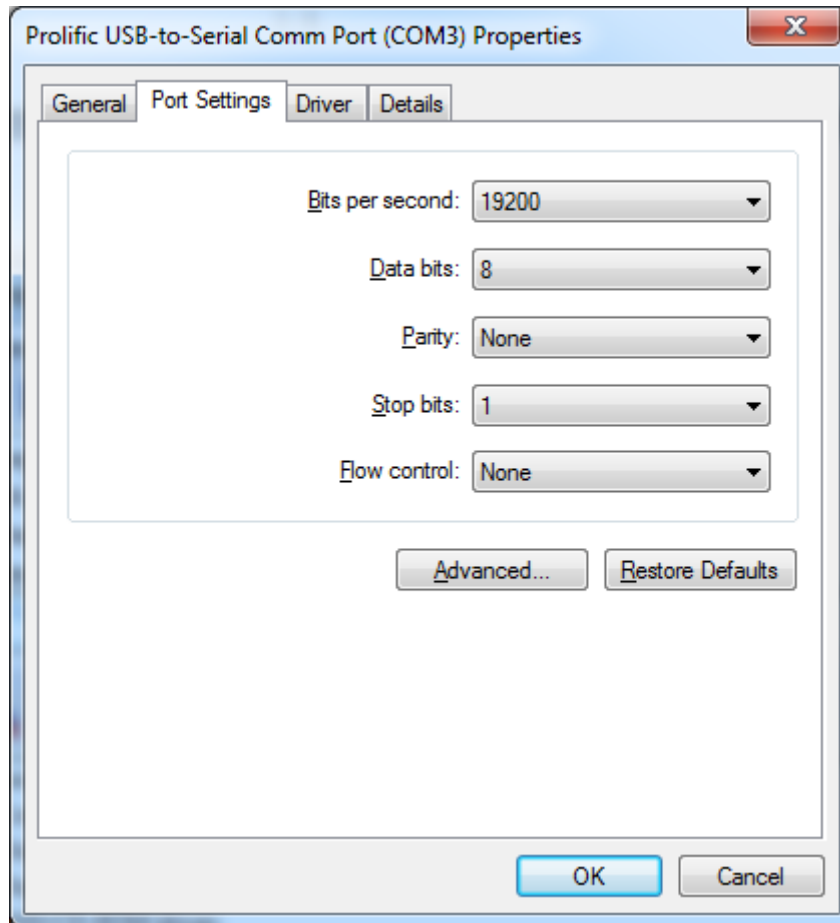
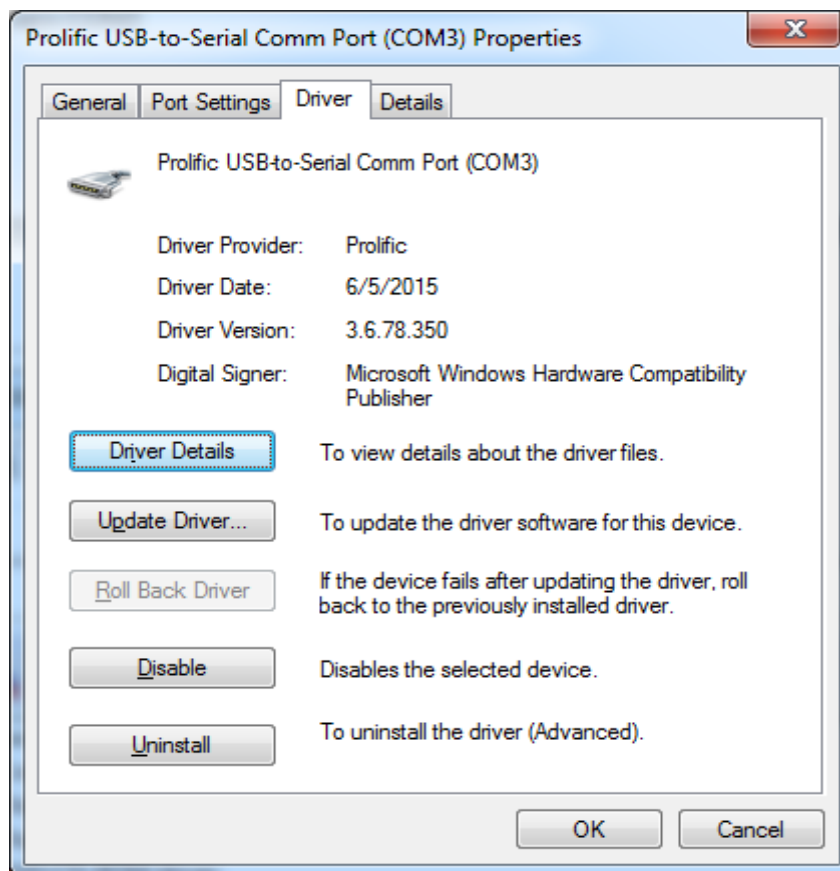
12) Select the 'Port Settings' tab and change the 'Bits per second' value to 19200. Click the 'Driver' tab and verify that the version is 3.6.78.350. Click the OK button and close Device Manager.

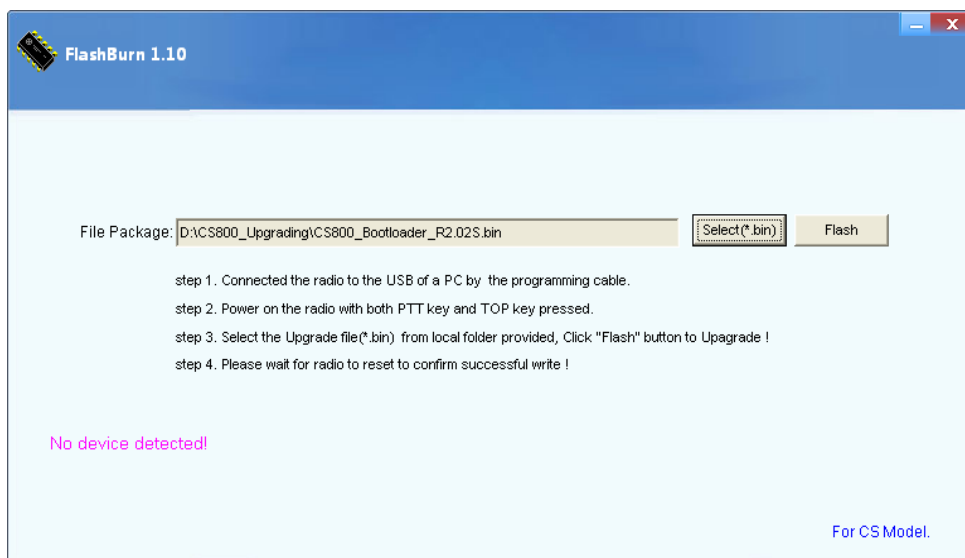
- 1) Connect your Mobile and PC with the DB15 programming cable. Run 'Flashburn1.10\_CSI.exe', and then press the 'P1 and Power Key' to power on the CS800. The LED should flash red and green and the software should indicate that the device is connected. Load 'CS800\_Bootloader\_R2.02S.bin', and then click the Flash button to start the update.

**After completion, please power off the radio and then power on. When there are characters shown on the front LCD, please power off the radio again. This process will backup the bootloader to its proper memory address.**

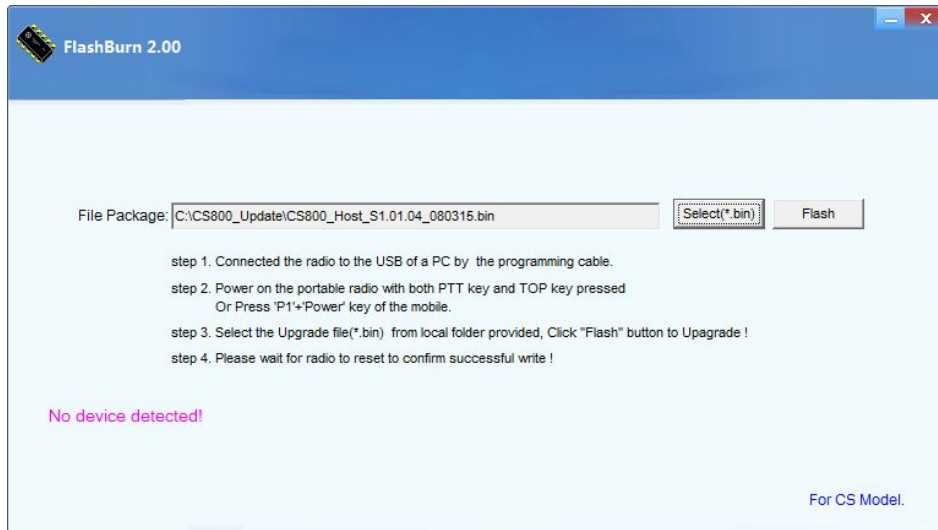
- 2) Run 'Flashburn2.00\_CSI.exe' and then press the 'P1 and Power Key' to power on the CS800 again. Load 'CS800\_Host\_S1.01.04\_080315.bin', and then click the Flash button. After completion, please power off the radio and disconnect the DB15 cable. This completes the update to the main MCU.

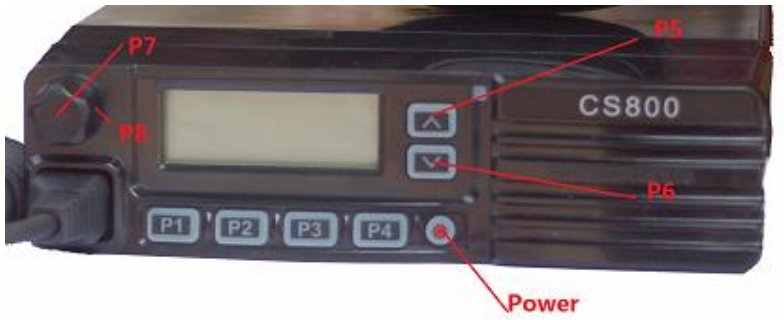
- 1) Please insert your RJ45 programming cable on the front USB connector of your desk computer or any USB connector of your laptop for one or two minutes (to verify that the USB to UART conversion IC runs correctly).
- 2) Press and hold P7 (do not spin) and then press 'Power', the RED LED will be lit and the front MCU will enter 'Program Mode'

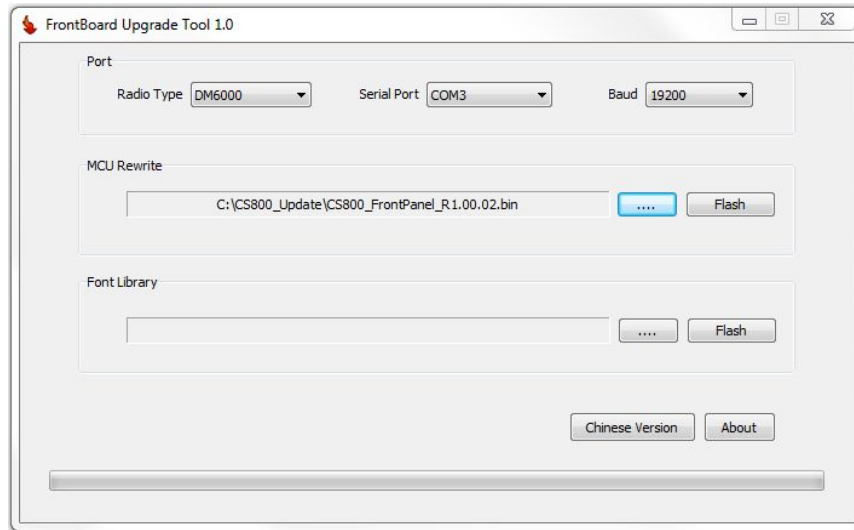
- 3) Run 'MobileFrontPanelUpgradeTool R1.0.exe' and set the correct serial port and baud rate (based on the information you obtained in step 5 of the driver installation procedure. Click the '...' button in the 'MCU Rewrite' field and load 'CS800\_FrontPanel\_R1.00.02.bin'. Click the 'Flash' button in the same field to run the update. **Please keep the radio and cable on a firm, stable surface to avoid inadvertant disconnections during the update.**

- 4) After the 'Upgrade Success' prompt from the PC, you can press the POWER key to power off the radio, disconnect the cables, and then power on it to check. Please note you need to upgrade the mobile MCU before you can operate the front panel keys, as there has been a change to the protocol of the key-values.
