D868UV firmware update V1.16 and V2.16

On the 2 version Firmware, we have renamed the firmware at the same number after the dot for both versions, so it came to V1.16 and V2.16 now.

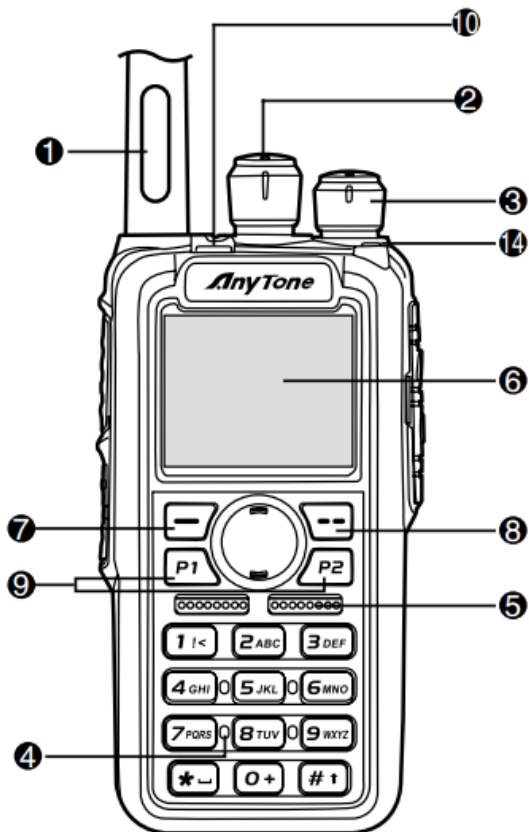
Press 7

(Menu) key to enter the menu, press

key to the Device Info and enter into the menu to check the hardware version.

Hardware V1.0 --- Please use the firmware V1.xx for updating the radio.

Hardware V1.1 --- Please use the firmware V2.xx for updating the radio.
